Statement

This statement is in relation to audible cracking noises in intermediate floors in domestic buildings. It is written as a joint statement between NHBC, GPDA and the Engineered Wood Product manufacturer's in the UKTFA based on the research commissioned by the 3 organisations to find the location and root cause of the noise. The investigation was carried out by the University of Salford Acoustics Research Centre. This statement reflects the findings and associated recommendations from the research: identifying the location of the cracking noise.

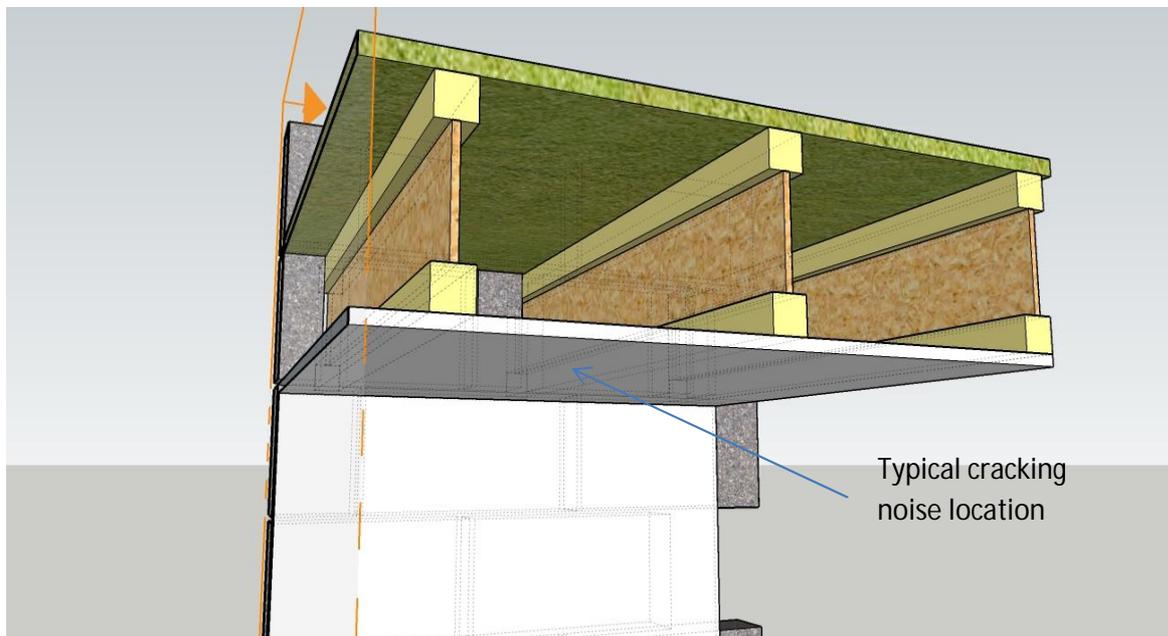
4. In all 3 properties the source of each dominant repeatable cracking noise was tracked to the junction between the wall lining and the underside of the floor structure at the point where a floor joist was built into the wall.

7. A simple saw cut between the wall and ceiling boards was not always, in itself, sufficient to fully eliminate all cracking noise sources.
8. Further investigation suggests this was because gypsum based adhesive dabs bridged the gap between the wall lining and the floor structure in some places.

13. Based on the findings of the research, in order to minimise the risk of such noise incidents occurring it is clear that particular care should be taken when constructing the junction between the blockwork wall, the wall/ceiling lining and the joists. The installer should avoid items interfering with the bottom of the joists. Specifically, care should be taken to ensure that gypsum plasterboard adhesive plaster dabs **do not** spread up the back of the plasterboard and set in contact with the lower flange of the joist.
